ROBERT L. MILLER, M.S.M.E., P.E.
CERTIFIED ACCIDENT RECONSTRUCTIONIST

Reference: Volpe Dedicated, Inc. & Gerardo Rodriguez advs. Felicia Melendez
Index No.: 22711/2012#
Civil Court Action No.: 12-CV-8846
Your File No.: 3371-1
CED Case No.: 52126.1

On November 9, 2012, CED was asked to review file materials, inspect an involved vehicle and visit the scene of a motor vehicle/pedestrian incident. The incident occurred on the morning of October 24, 2012, at/near the intersection of Story Avenue and White Plains Road in the Bronx, New York. The incident took place at approximately 6:26 am (sunrise 7:17 am). Ms. Felicia Melendez was crossing White Plains Road, in an easterly direction, when she was struck by a Volpe Dedicated, Inc. (Rite Aid) tractor and semi-trailer. The purpose of the CED investigation was to determine the cause of the incident.

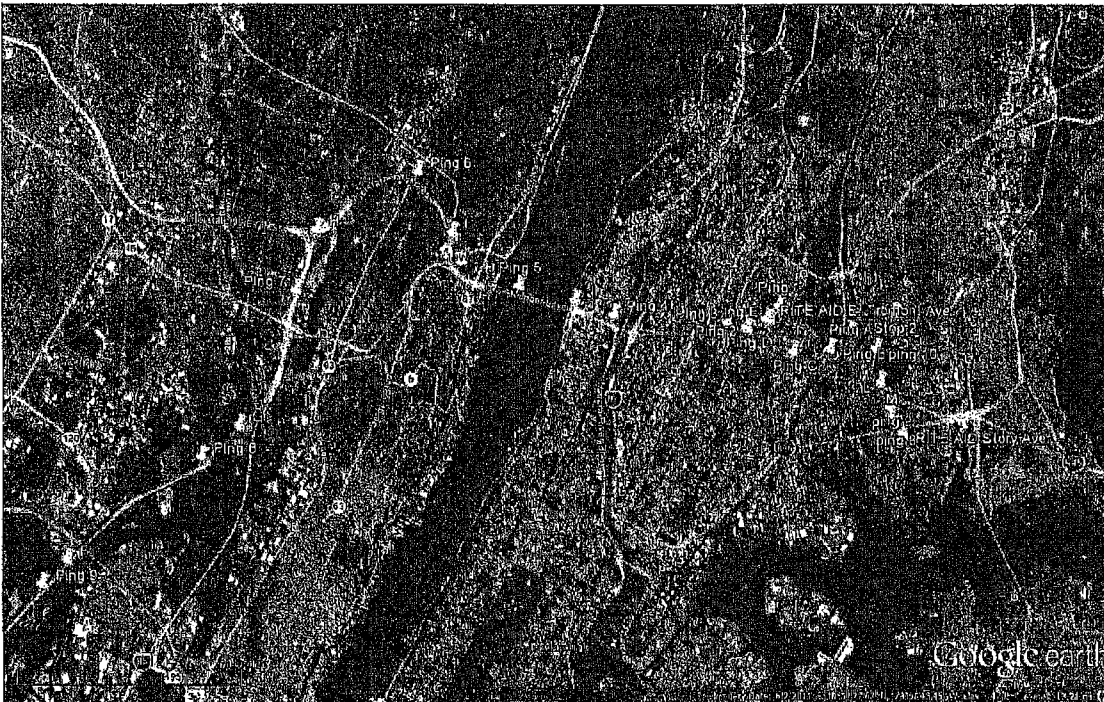
Figure 4 - GPS positions for Mr. Rodriguez truck 10/24/2012.

CED utilized the GPS information to create a map showing the various locations of Mr. Rodriguez tractor from a position on the New Jersey Turnpike and back, including his travel in the Bronx making his three stops. Figure 4 provides this mapping.

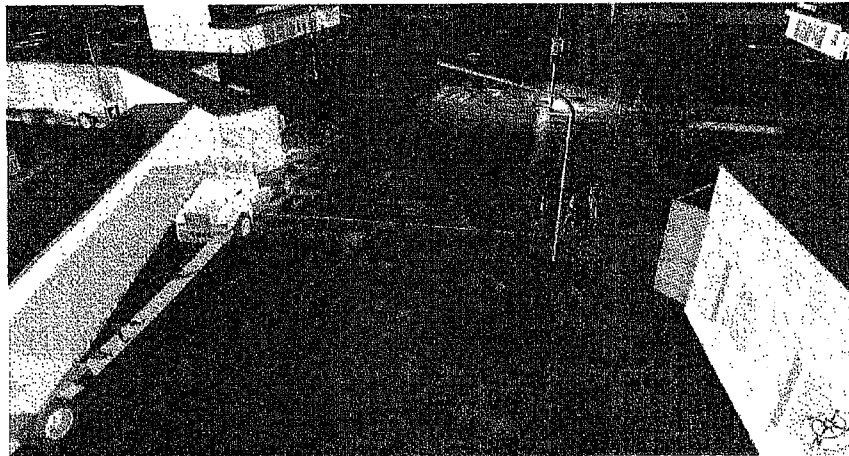
Figure 6 -Melendez Scenario

Mr. Rodriguez. However on page 53 of her deposition, Ms. Melendez testified with respect to the trucks approach, "Not from the right or the left, but from the other side. ... From this side of Story." (page 53). Ms. Melendez stated that she was impacted by the truck on her right side and was knocked down and went underneath the truck. While under the truck she was screaming and yelling and she felt something on her leg. Ms. Melendez also stated that she was dragged a short distance but did not know what part of the truck dragged her. Ms. Melendez did not recall where she came to rest after the truck passed over her. Figure 6.

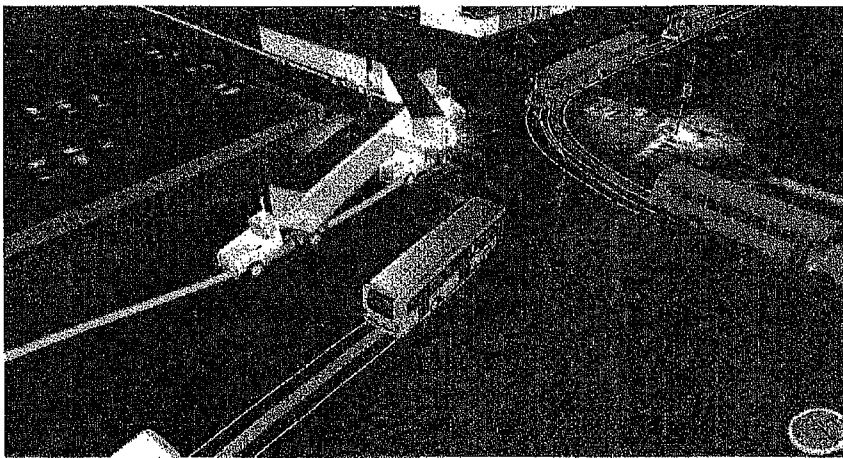
Figure 7 -Rodriguez Scenario

westbound on Story Avenue and saw the traffic light at White Plains Road turn red. When Mr. Rodriguez reached White Plains Road, he stopped his truck to wait for a green signal to make a right turn onto White Plains Road northbound. Mr. Rodriguez indicated that there was a car behind him at the red light. While Mr. Rodriguez was stopped he observed a few vehicles traveling from his left to right on White Plains Road including a school bus. The school bus stopped in the intersection and ultimately made a left turn onto westbound Story Avenue. Mr. Rodriguez also saw an MTA bus southbound on White Plains Road which stopped for a red light at Story Avenue. Mr. Rodriguez did not see any pedestrians on the northwest corner of the intersection or in the crosswalk on the north side of the Story crossing White Plains. Additionally, Mr. Rodriguez did not see any pedestrians on the west sidewalk of White Plains, ahead of or behind the stopped MTA bus. Mr. Rodriguez had a clear, unobstructed view of the northwest corner and the north crosswalk. If a pedestrian were on the northwest corner or in the north crosswalk, they would have been clearly visible to Mr. Rodriguez. When the light turned green for Story Avenue, Mr. Rodriguez waited for the school bus to complete its left turn before he began to execute his right turn. As Mr. Rodriguez was completing his turn, he checked his right side rear view mirror to ensure he had cleared the sidewalk at the NE corner of the intersection. Mr. Rodriguez then looked forward and he saw something in his left (driver side) upper outside mirror and did not know what it was. Mr. Rodriguez stopped his truck, exited the tractor and began to walk back to see what it was. Mr. Rodriguez saw a woman on her back lying in the road complaining of pain in her leg.

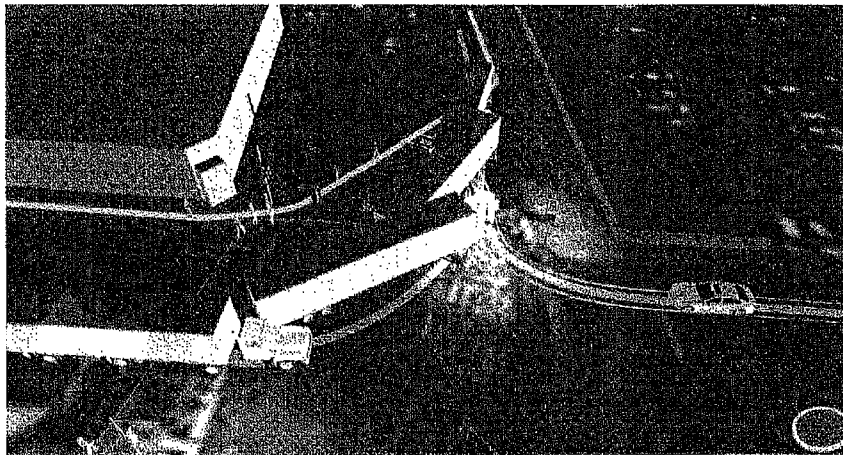
Figure 8 -Jankee Scenario

Mr. Jankee testified that he observed a Rite Aid tractor trailer approaching the intersection of White Plains Road and Story Avenue in an eastbound direction on Story Road on the west side of White Plains. Mr. Jankee made this observation as he was approaching White Plains on Story, in a westbound direction and while he was stopped for a red light at White Plains Road. Mr. Jankee was the first vehicle in line stopped for the red light. While

stopped, Mr. Jankee testified that he "Checked my surroundings. Saw a truck coming towards me, pedestrians on the street corner of the restaurant, other vehicles on my right-hand side waiting to go north to south. Vehicles on my left-hand side." Additionally, Mr. Jankee indicated there was a car behind him. With respect to the approaching truck, Mr. Jankee indicated "You can see it being a tractor trailer and you can also hear it. ... I had my driver's side window cracked just at the top." The pedestrians (2) observed by Mr. Jankee were on the northwest corner of the intersection. When the light turned green, Mr. Jankee observed the pedestrians crossing White Plains Road, one in the crosswalk and the other "In the north lane crossing between cars." Mr. Jankee testified that he did not begin his right turn due to the left turning Rite Aid truck, which had entered the intersection. Mr. Jankee lost sight of the pedestrian in the crosswalk but observed the pedestrian that was north of the crosswalk reach the east sidewalk along White Plains Road. Mr. Jankee indicated that he observed what he thought was garbage, tumbling under the trailer of Mr. Rodriguez truck. Mr. Jankee testified that he did not make this observation until the truck was straight going north bound on White Plains Road. Additionally, Mr. Jankee indicated the truck was clear of the crosswalk at the time of his observation of the garbage. After Mr. Rodriguez's truck passed over the garbage, Mr. Jankee realized it was actually a person.
